# Manhole Inspection Summary

Manhole # S29SS\_002MH

Insp Date: **8/5/08 9:17 AM**

**Location** Address: **2800 FALLS RD**

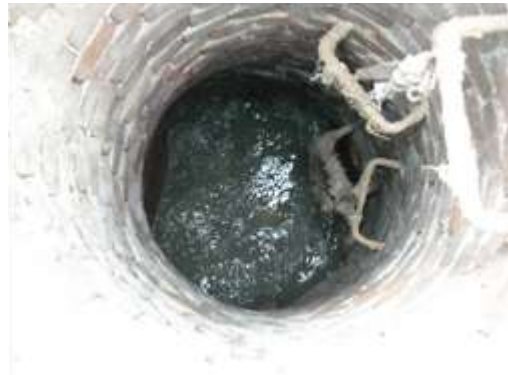
Top View

Corroded steps. Evidence of surcharge - Bench debris.

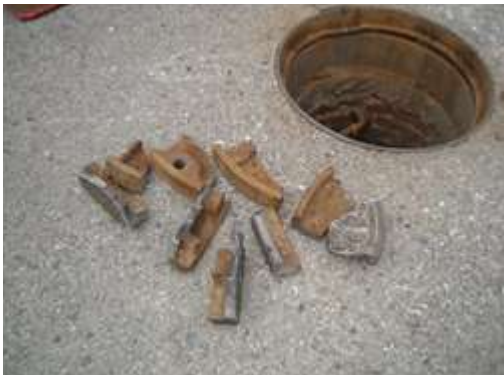
Broken lid

Replaced lid

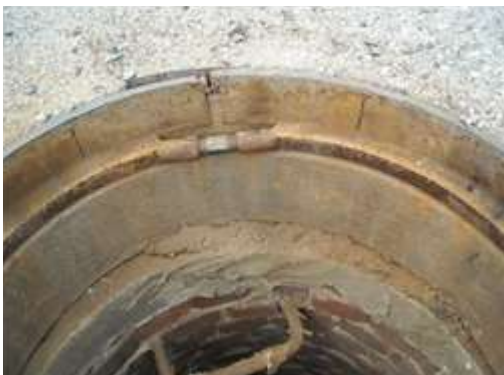
Metal Frame Adjustment

Caused cover to be stuck.

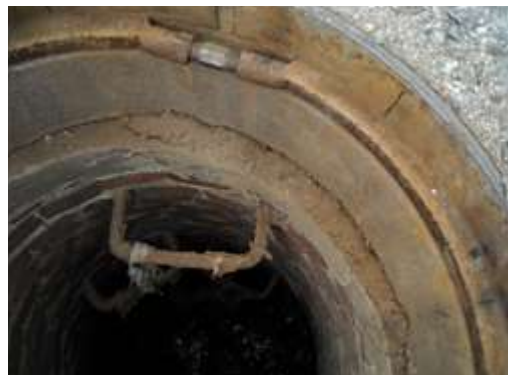
Defect

Frame leaks. Frame offset. Adjustment

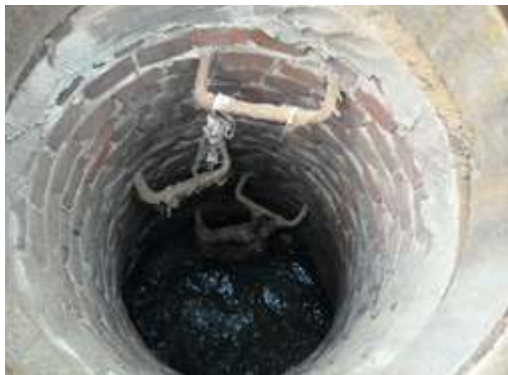
Defect

Frame leaks. Frame offset. Adjustment and Barrel infiltration.

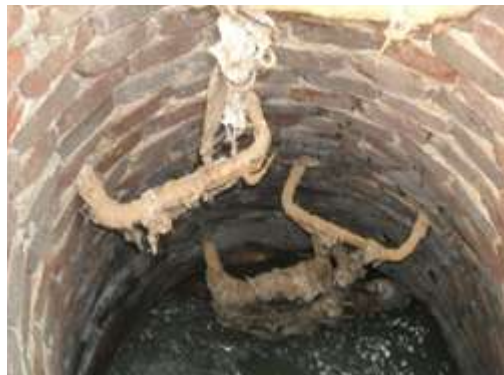
Defect

Barrel infiltration.

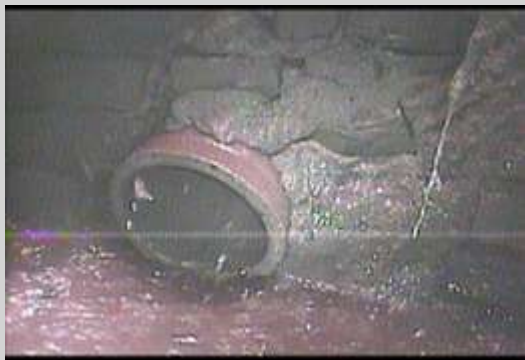
### 6 in. Circular Gravity Sewer Pipe In @ 3 O'Clock

Infiltration: **None** Pipe Seal Cond: **Cracked**

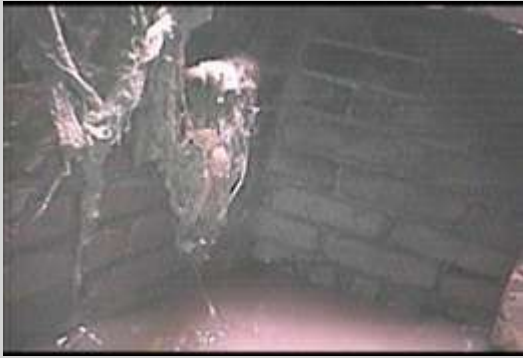
### 18 in. Circular Gravity Sewer

The pipe is below the water level.
